Geotechnical characterization for a large urban excavation in Manizales, Colombia

Abstract

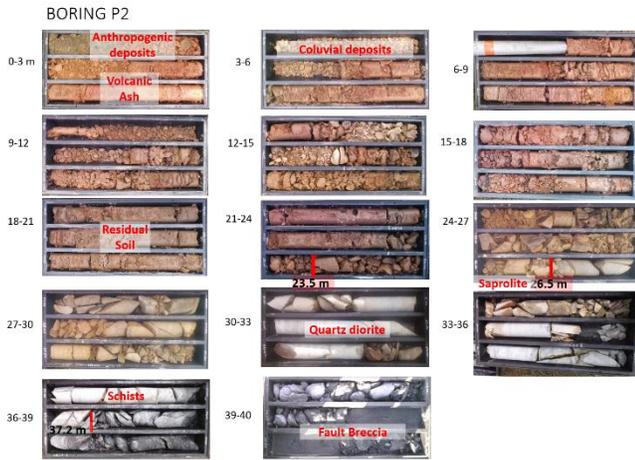
Figure 4 - Photographic record of P2 drilling located in the middle part on the northern border of the project area.

Figures 4 and 5 show the photographic record of two of these bore holes. It can be seen that a continuous recovery was achieved in all the materials, which could establish an adequate geological description and geo mechanical classification of the rocks as well as perform tests on cores of unaltered material. The presence of a quartz diorite intrusion was identified along the shear area. It was also found that schists in the shear zone are completely disintegrated and weathered, giving place locally to a gravelly soil in silty matrix with clay gouge veins, along the zones of greatest affectation.

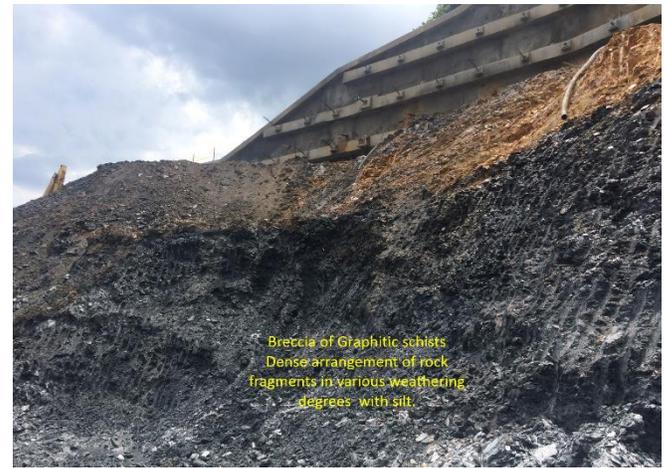
Figure 7 - Excavation slope in the fault zone in the center of the project area.

Superficially there are deposits of volcanic ash originating in various eruption events of the snowy Ruiz volcano which is located about 29 km to the south east of the city. Due to the frequent instability phenomena caused by shallow slides and ash cover, as well as anthropic deposits, it is common to find surface deposits of earth flows. Figures 4 and 5 show photographic records of exploration drilling made during design, where the different materials found in the area can be seen. Figures 6, 7 and 8 show photographs of materials found during excavation for the project.

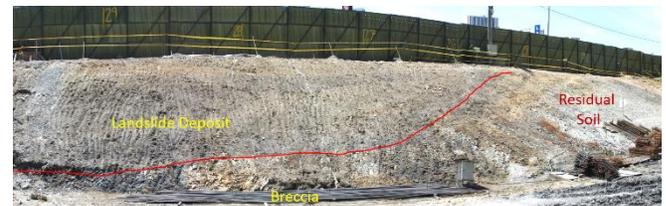
Figure 8 - Excavation slope the western side of the project.

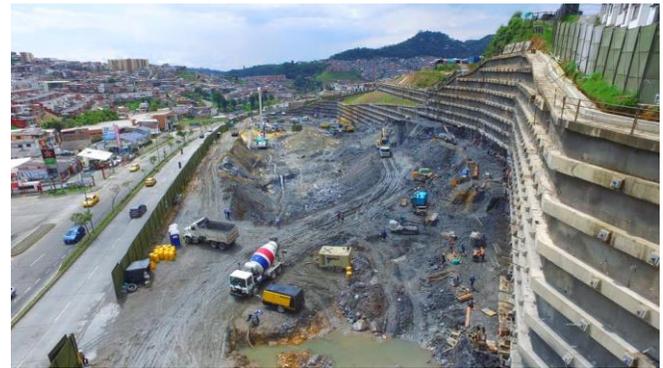
Figure 12 – View of the excavation during construction.

Figure 12 show the contention wall during construction in a view towards the west. The higher zone of the wall under construction can be seen to the right in the photo. The general extension and the context location of the urban excavation is shown in Figure 13.

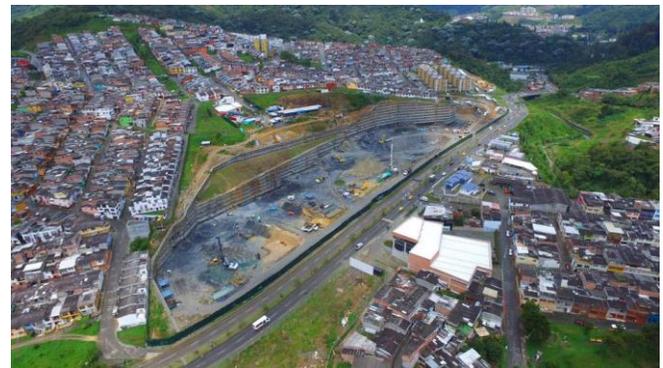
Figure 13 – Air view of the excavation during construction.
